Re: George Lake Flooding Analysis—March 9, 2018 DRAFT
Village of Bristol, Wisconsin

George Lake
Flooding
Analysis

George Lake Flooding Analysis

EXECUTIVE SUMMARY

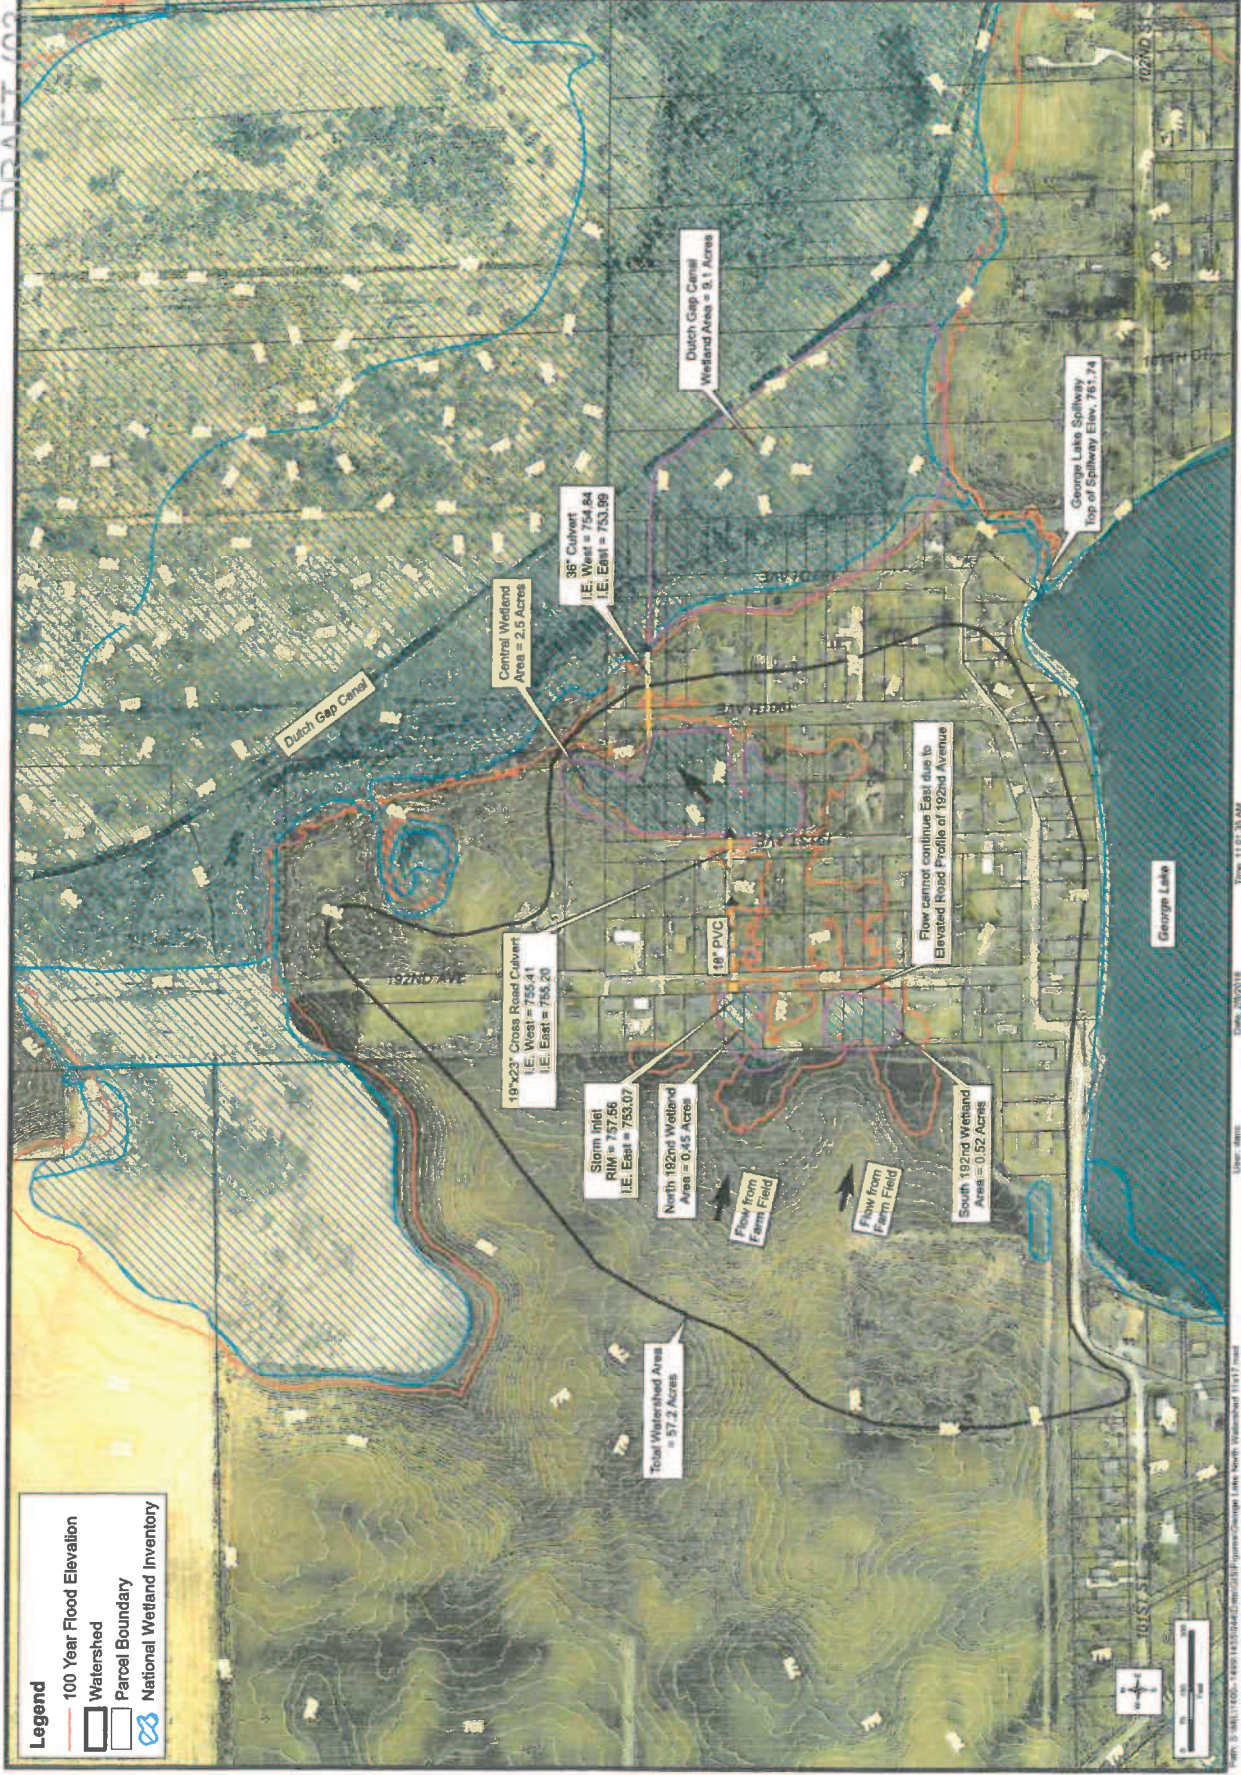
**STRAND
ASSOCIATES**
FIGURE 2
1455.044

**GEORGE LAKE AREA
DRAINAGE PATTERNS
VILLAGE OF BRISTOL
KENOSHA COUNTY, WISCONSIN**

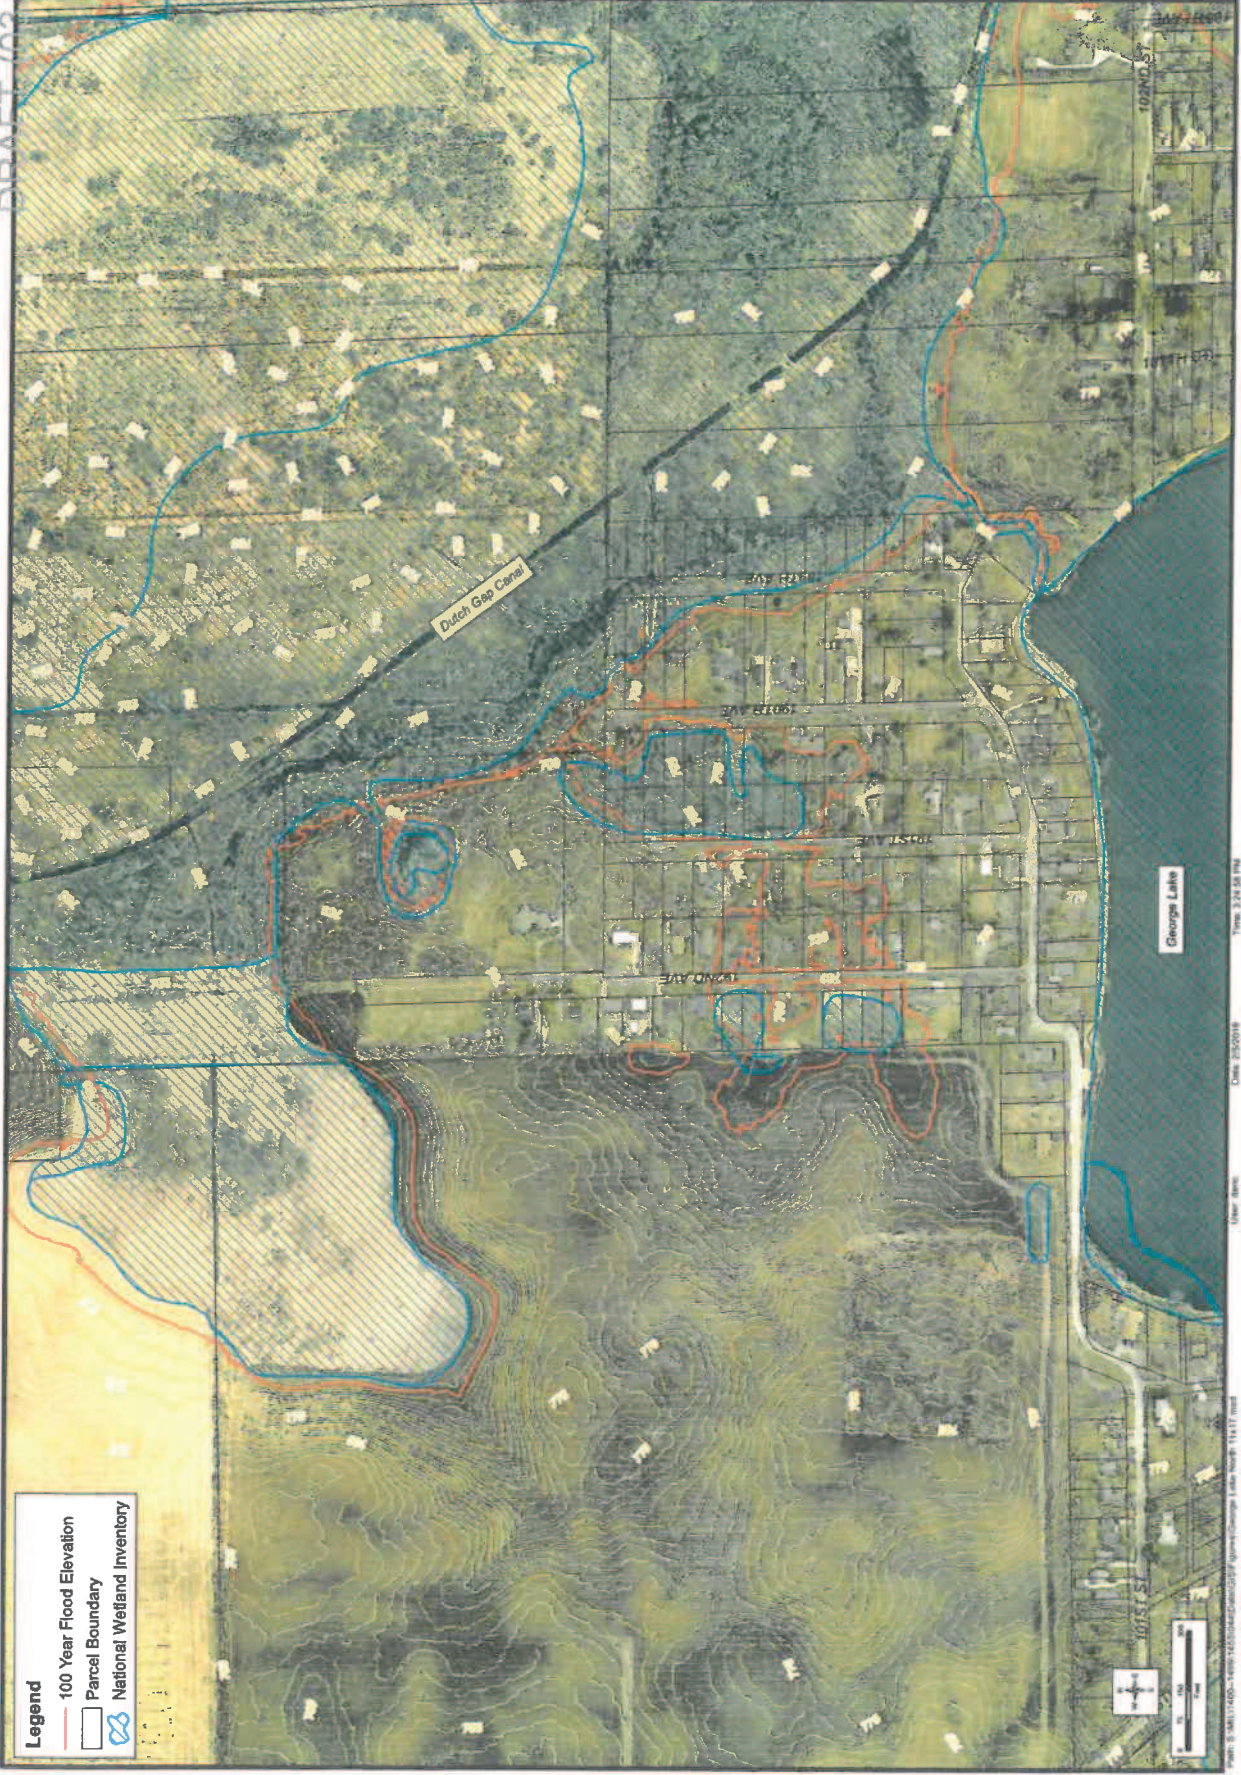
Included in the FEMA FIS that was done for Kenosha County was a Flood Insurance Rate Map (FIRM) for the George Lake area. Among other things, this map shows the 100-year floodplain elevations for the area. Generally, the 100-year floodplain elevation for George Lake is 763, and the floodplain elevation for the Canal is 759. Figure 1 shows the limits of the 100-year floodplain in the George Lake Neighborhood, and there are a total of 54 parcels that are fully or partially located within the 100-year floodplain. The FEMA FIS for Kenosha County and the FIRM for the George Lake Neighborhood can be found in Appendix A.

**GEORGE LAKE AREA
100-YEAR FLOOD ELEVATION
VILLAGE OF BRISTOL
KENOSHA COUNTY, WISCONSIN**

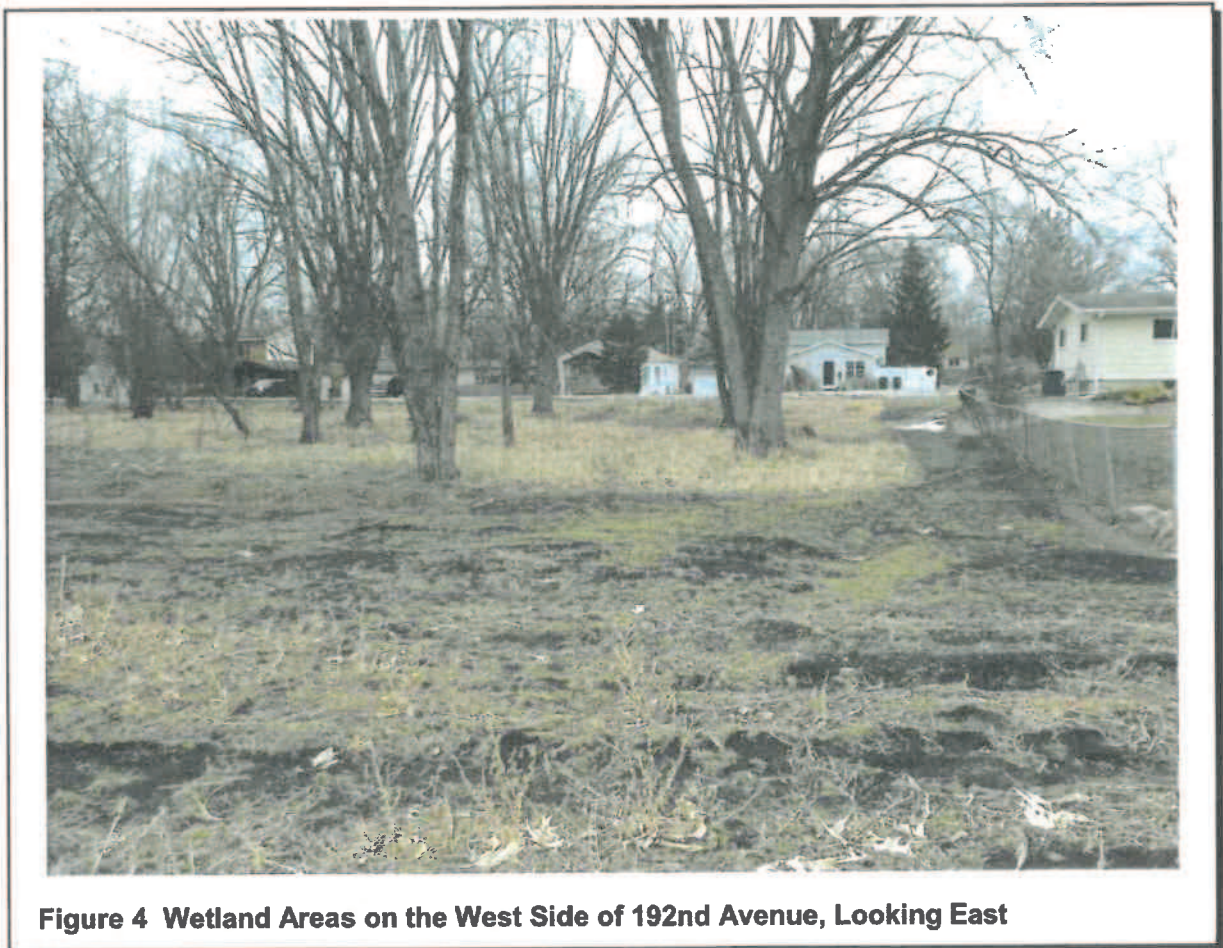
A large portion of stormwater runoff enters the George Lake Neighborhood from farm fields located west of the neighborhood. Once runoff leaves the farm fields, it collects in two places on the west side of 192nd Avenue. There are vacant lots to the north and south of 9902 192nd Avenue where water collects as it runs off the farm fields. In each area, there are classified wetlands present, and drainage cannot continue to flow east because of the elevated road profile of 192nd Avenue (refer to Figure 4). However, in the lots north of 9902 192nd Avenue, there is an inlet that collects stormwater once the water level is high enough.

Water flows into this inlet and through an 18-inch PVC pipe to the east under 192nd Avenue, 191st Avenue, and eventually toward the Canal. There is no inlet to drain the vacant lots south of

9902 192nd Avenue, and once runoff reaches this area it is effectively trapped until it infiltrates or evaporates.

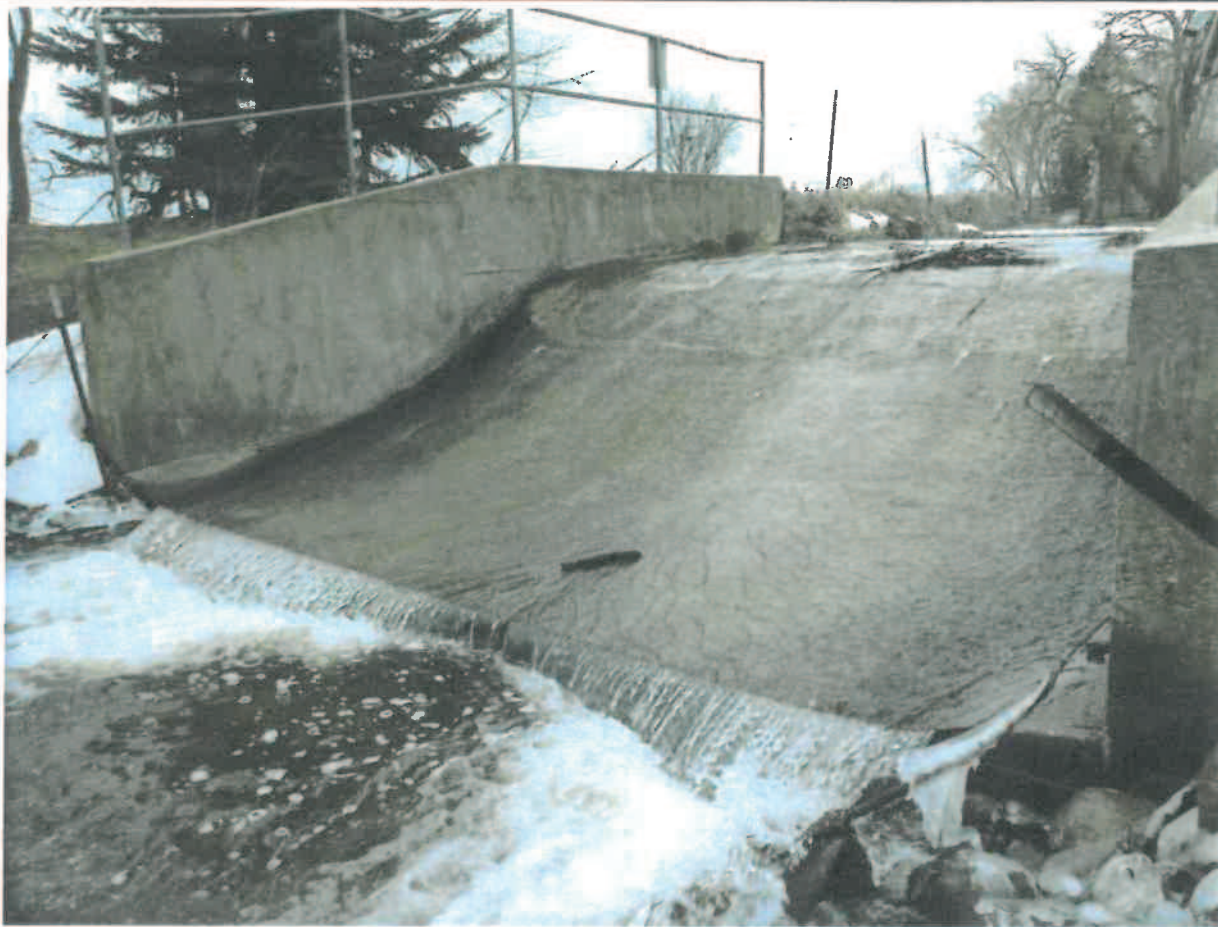
Figure 5 George Lake Spillway

The normal water level of George Lake is controlled by a concrete spillway that is located at the northeast side of the lake (refer to Figure 5). The spillway consists of a concrete structure where the water flows over the top and into a creek that eventually runs into the Canal. As the water leaves George Lake over the spillway and into the creek, it flows to the north and east until it reaches the Canal wetlands area where it collects and ponds before making its way into the Canal (refer to Figure 6).

It was suspected that during the July 2017 flooding event, the water levels of George Lake rose to a level that was higher than the road profile of 101st Street on the northwest side of George Lake. Strand staff spoke with several residents that live near the northwest side of the lake, and none were able to confirm whether or not the flood levels of George Lake rose above 101st Street and contributed directly to the flooding in the George Lake Neighborhood. Strand's field survey did, however, confirm that the centerline road profile for 101st Street is approximately 1.4-feet higher than the 100-year flood elevation of George Lake. This confirms that a 100-year storm will not cause George Lake to rise above 101st Street and flow into the George Lake Neighborhood.

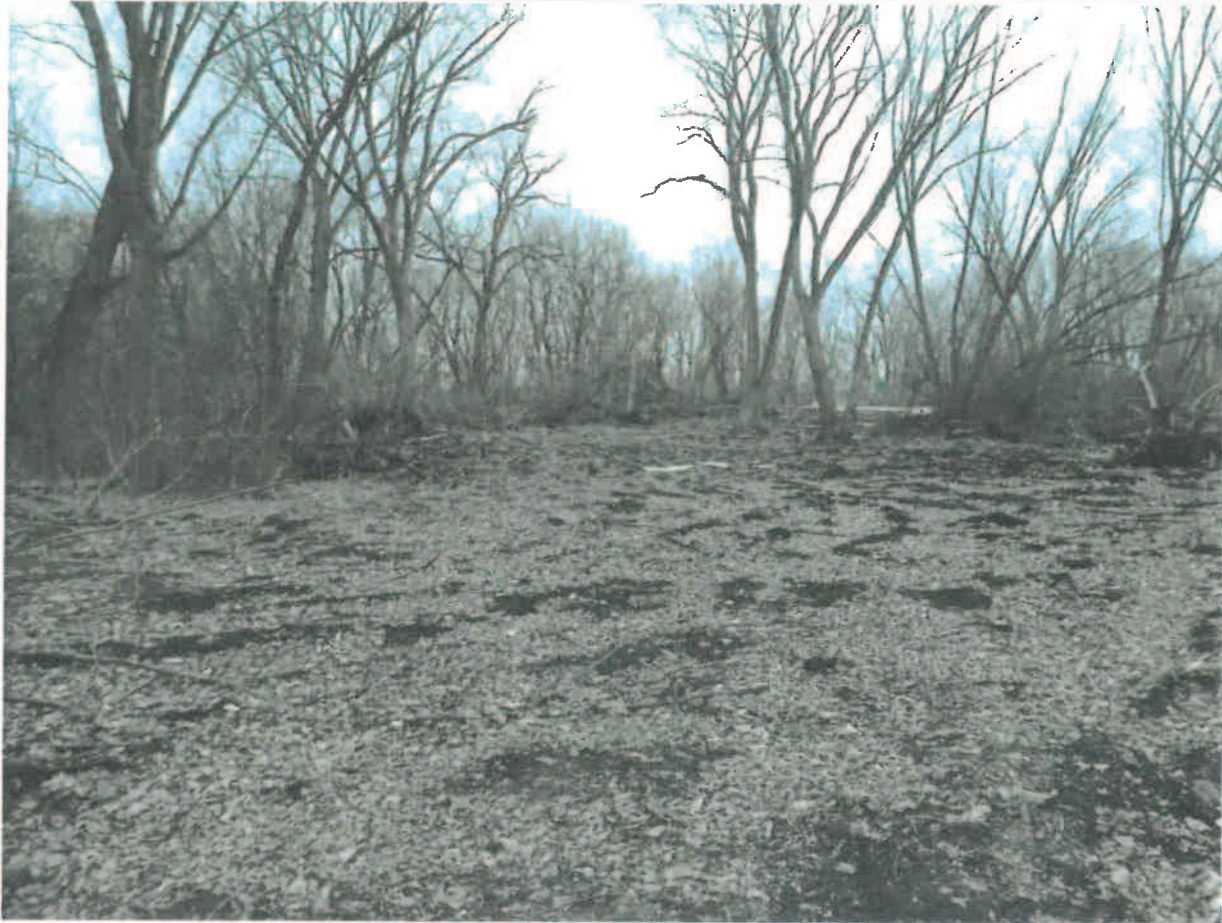
Figure 7 Central Wetland Area

There is a large, approximately 2.5 acre area (refer to Figure 7) located within the north side of the George Lake Neighborhood between 191st Avenue and 190th Avenue that is located within the 100-year floodplain for the Canal. This area is a natural low point within the George Lake Neighborhood that collects surface runoff from within the neighborhood. There is also a 19-inch by 23-inch culvert underneath 191st Avenue that brings water from the west side of 191st Avenue

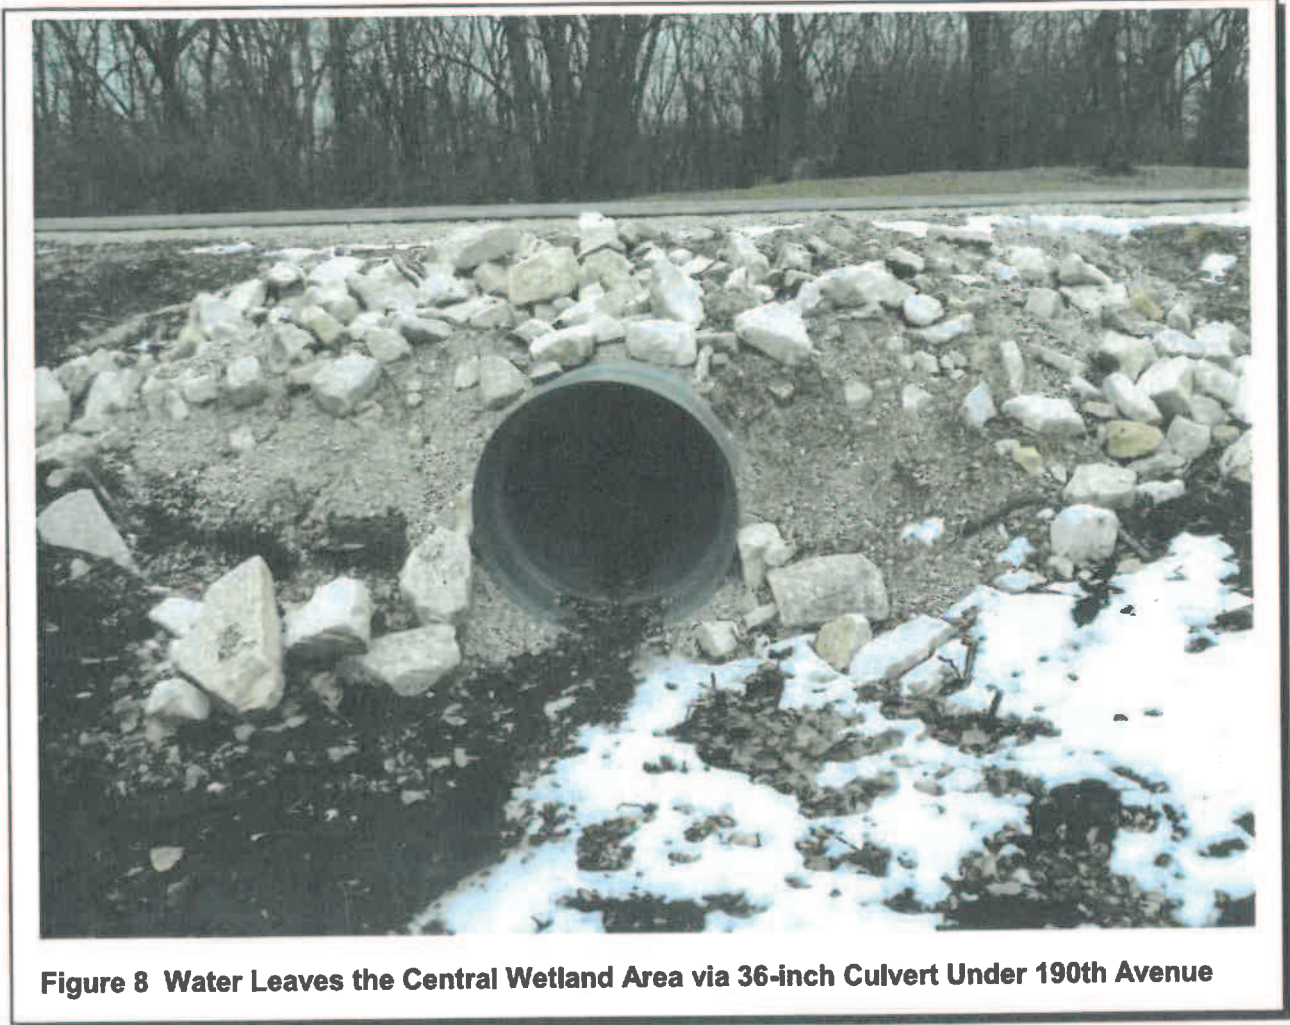
Figure 8 Water Leaves the Central Wetland Area via 36-inch Culvert Under 190th Avenue

to the east side of the road. The water can exit the wetland area via a 36-inch culvert that is installed underneath the north end of 190th Avenue (refer to Figure 8). Water flows through this culvert and runs into the lowland area west of the Canal before flowing into the Canal. This central wetland area is essentially functioning as a large dry detention basin. The flow route from the 19-inch by 23-inch culvert at 191st Avenue to the 36-inch culvert at 192nd Avenue is approximately 325-feet long, but only has about a 0.1-percent slope. The entire area is extremely flat and likely makes it difficult for water to flow.

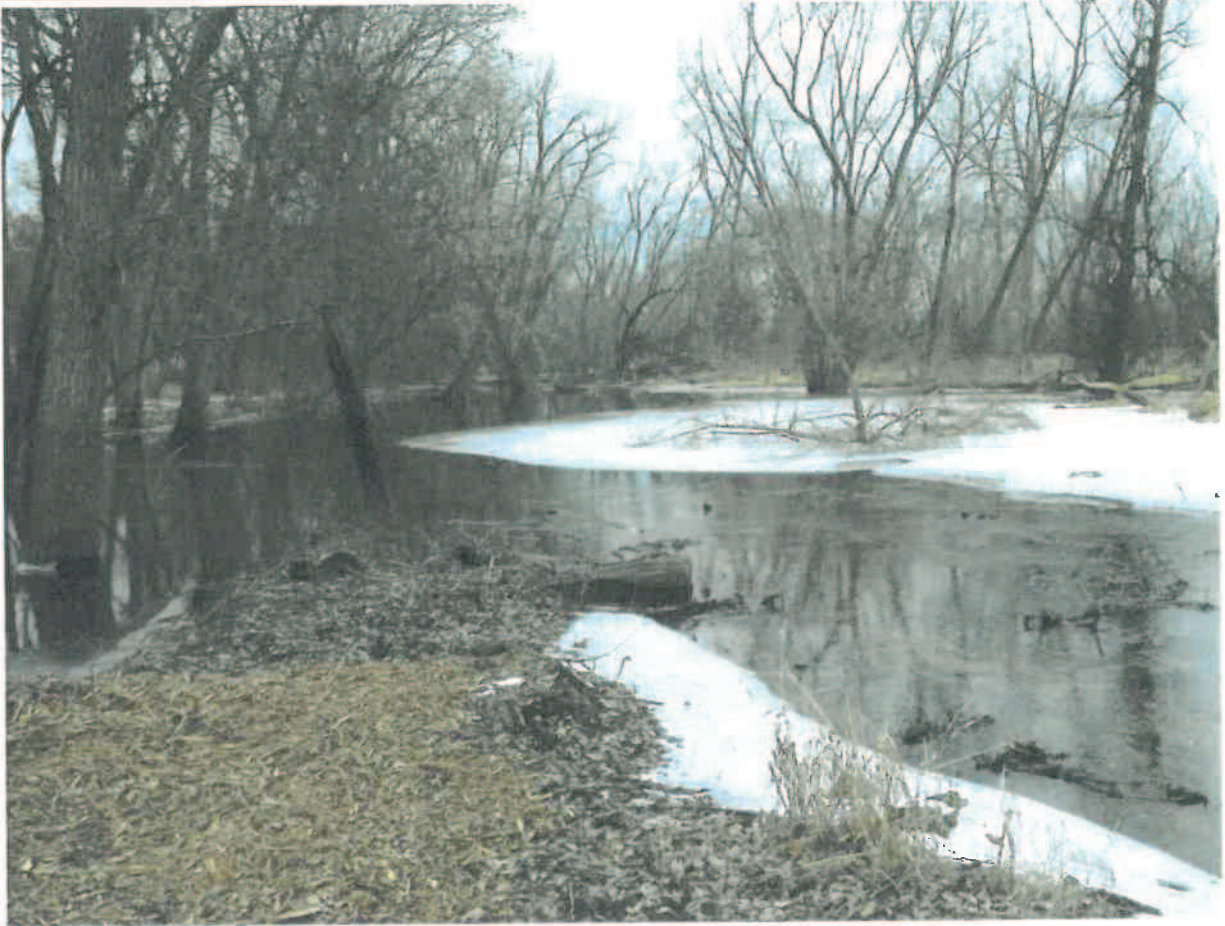
During Strand's field investigation, Strand staff saw evidence of beaver dams located along the Canal. Strand discussions with residents of the George Lake Neighborhood also confirmed that beaver dams are common along the Canal. These beaver dams may contribute to flooding that occurs within the George Lake Neighborhood. The Village should continue coordinate with both Kenosha County and the WDNR, as well as private landowners, about further investigation of beaver dams on the Canal, their impacts to flooding in the area, as well as possible ways to minimize or mitigate their effects on the neighborhood.

Figure 9 Looking North as Water from George Lake Spillway Collects and Ponds in Dutch Gap Canal Wetlands with No Direct Route to the Dutch Gap Canal

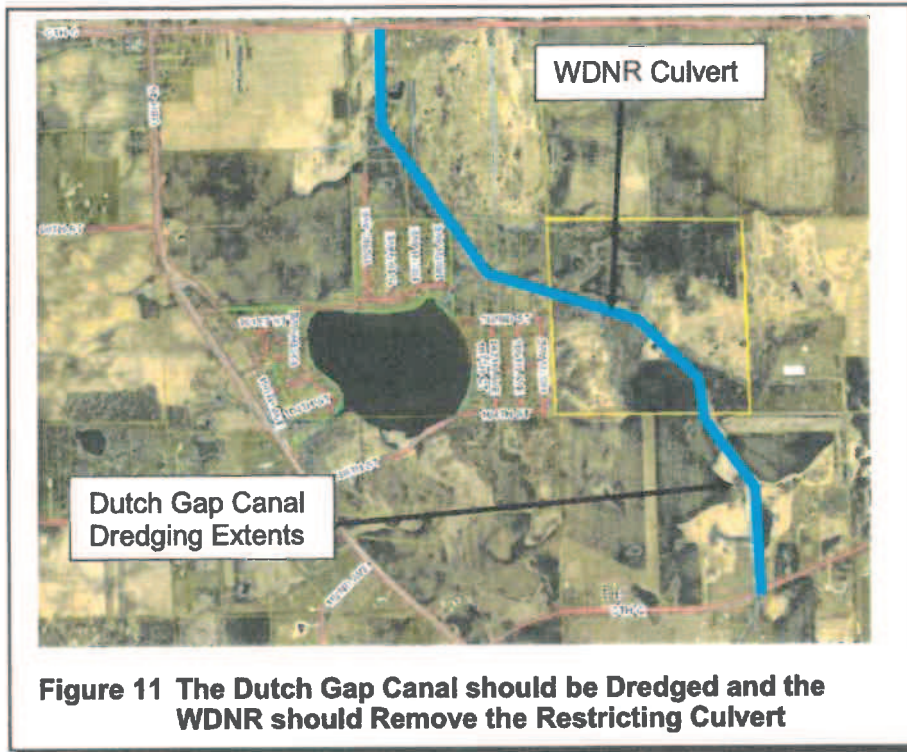
The neighborhood drainage is not likely to improve until the flow restrictions on the Canal are removed. Figure 11 presents an overview of the Canal recommendations.

1. The WDNR should remove the culvert located on its property (refer to Figure 11).
(Near Term, \$5,000)
2. Dredge the Canal from CTH Q to CTH C.
(Near Term, \$2,000,000)

The Dutch Gap Canal should be dredged from County Highway Q to the south, upstream to County Highway C on the north. This effort would require coordination between 14 private property owners, the WDNR, Kenosha County, and the Village. This effort would include dredging approximately 10,000 linear feet of mainline channel plus small branches of channel.

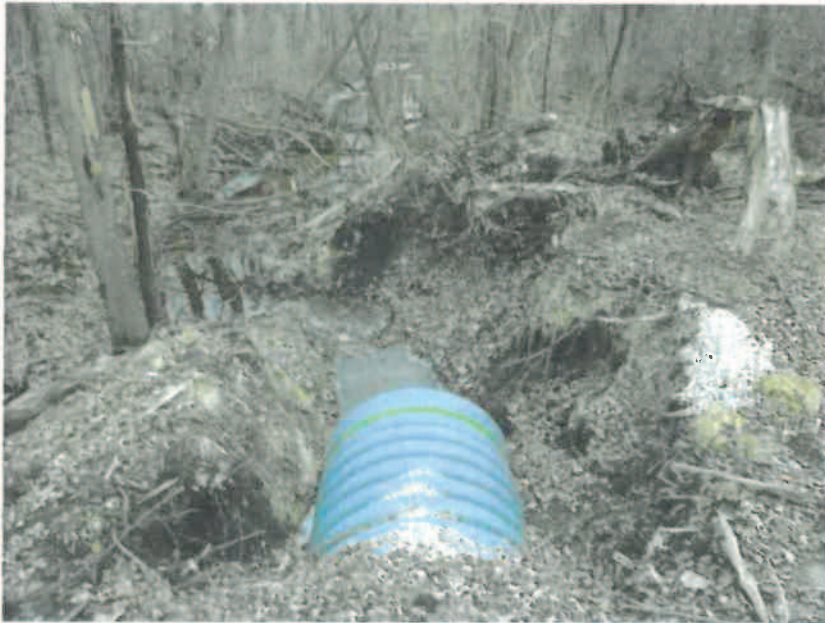
Once stormwater leaves the 36-inch culvert that daylight east of 190th Avenue, there is no clear path or creek for the stormwater to be conveyed to the Canal. Currently, the flow path from the culvert runs through a heavily wooded area that may be full of branches, fallen trees, and other debris, and once water does reach the Canal Wetland Area there is no direct route for the water to reach the Canal. Owners of these vacant lots should dredge the existing flow route to clear it of branches, sediment, and debris, and create a more direct channel for water to flow toward the Canal (refer to Figure 12). Owners of these lands include private property owners and Kenosha County.

Figure 12 Owners of Vacant Lots Must Remove Branches and Maintain a Flow Path to the Dutch Gap Canal.

1. **Dredging Central Wetlands Outfall and Bank Stabilization
(Near Term, \$60,000)**

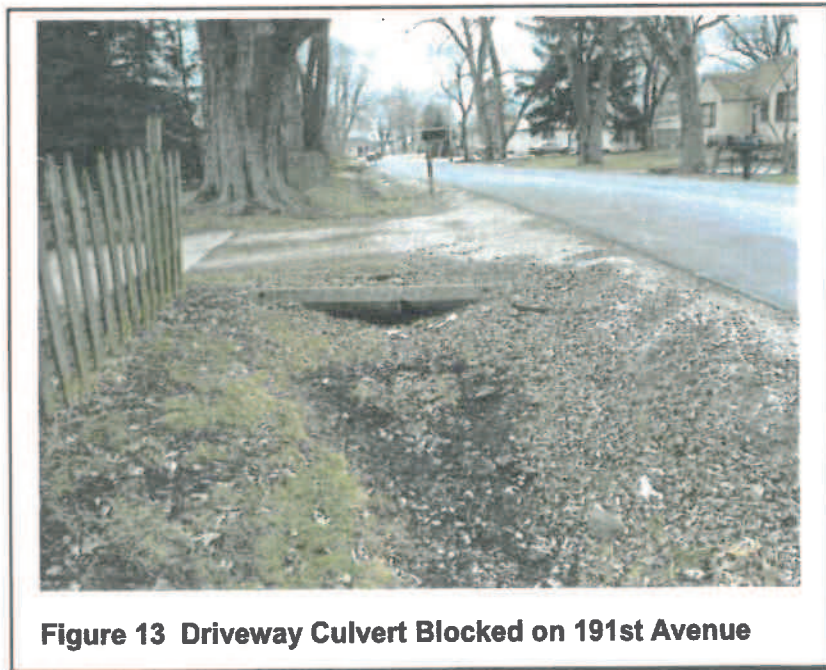
Driveway culverts are owned by the individual homeowners. During Strand's field survey, many of the driveway culverts appeared to be damaged or collapsed, and others were blocked with debris or buried (refer to Figure 13). The Village recently resurfaced the roads in this neighborhood and offered to replace driveway culverts for the cost of materials only, which was approximately \$750 each. Unfortunately, property owner participation was only approximately 10 percent. Improving the flow through the culverts will help water to drain more readily to the Canal, which will be most effective after the Canal is drained. Until then, water will be able to move more freely in the local drainage system but will still have essentially nowhere to drain to.

2. **Driveway Culvert Replacements and Repairs**
(Most effective after the Canal is dredged, \$2,000 per property)

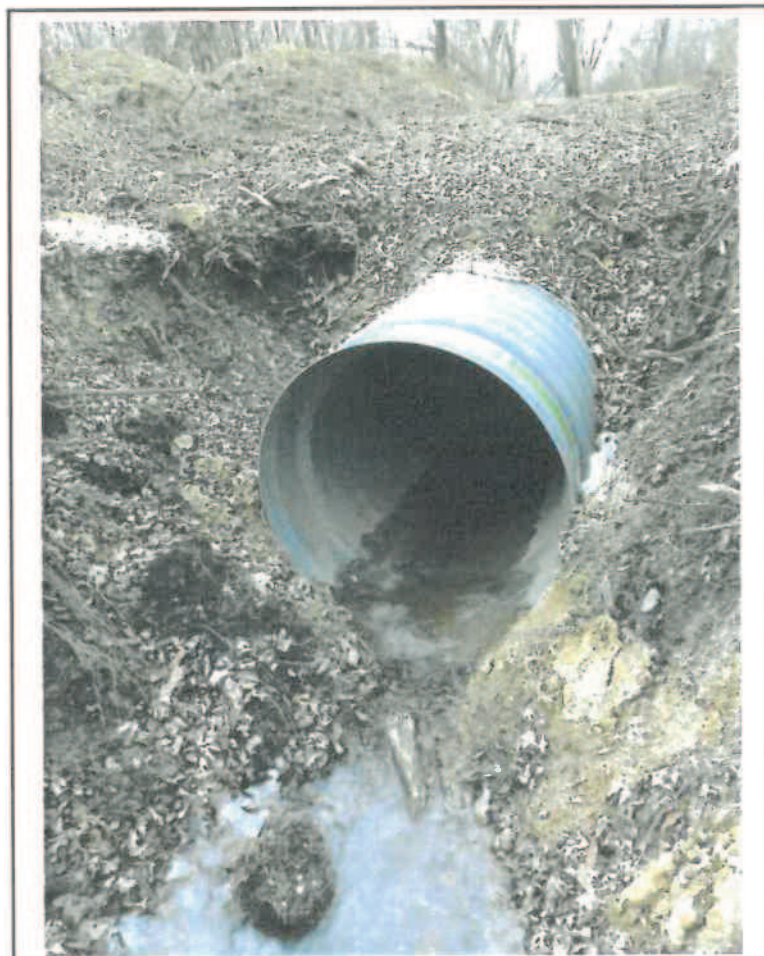
Figure 14 Potential Installation of Backflow Preventer on Culvert Outfall at 190th Avenue

There is a 36-inch culvert that runs underneath the north end of 190th Avenue (refer to Figure 14) and drains stormwater from the Central Wetland Area toward the Canal Wetlands Area. The culvert daylights on the border of Village-owned property and private property with the downstream ditch being located on private property. We assume the Village has jurisdiction over this pipe, but that should be verified. The invert elevation of this discharge is at a lower elevation than the creek that flows from the George Lake Spillway. Therefore, when water levels get high enough in the Canal Wetland Area, water may flow back into the George Lake Neighborhood through this culvert. A backflow preventer such as a duckbill check valve should be installed to prevent water from flowing into the George Lake Neighborhood from the Canal Wetland Area.

3. Install Culvert Backflow Preventer
(Near Term, \$14,000)

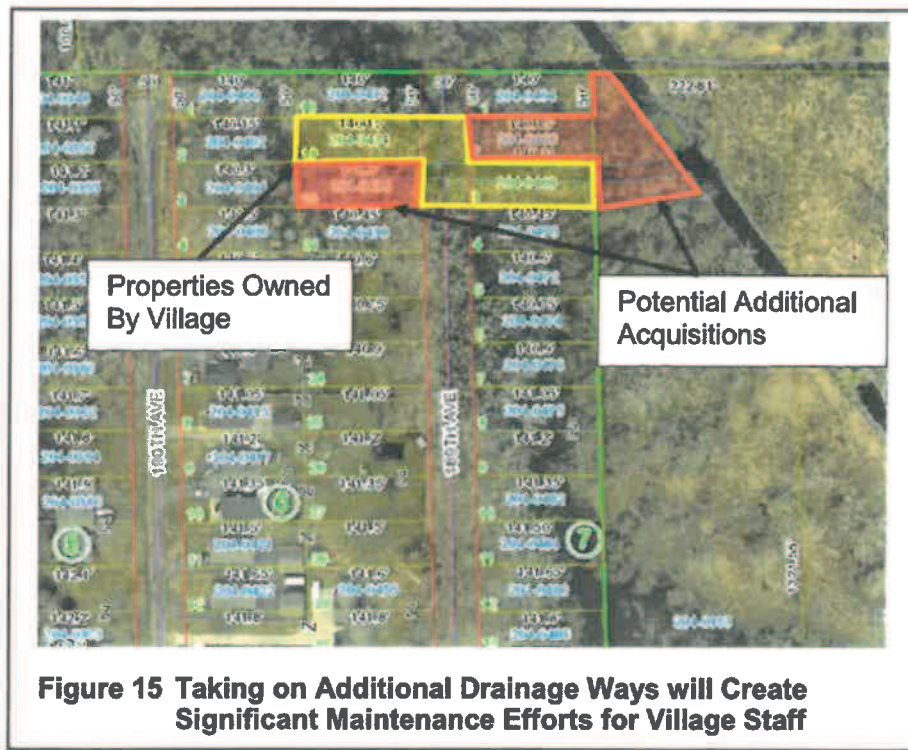
Should the owners of vacant lots be negligent in their responsibility to maintain drainage ways, the Village could pursue the acquisition of additional properties to take over maintenance responsibility. The maintenance responsibility would mean stabilizing the banks and dredging as frequent as necessary, and removing debris before and after each storm. This could add a significant burden of time and cost to the Village. This would require the acquisition of two additional lots (parcel nos. 37-4-121-204-0466 and 37-4-121-204-0436) and a drainage easement through parcel no. 37-4-121-204-0153, shown in Figure 15.

4. Acquisition of Drainage Way Properties and Frequent Maintenance
(Near Term, \$100,000 Acquisition, \$30,000 Annual Maintenance)

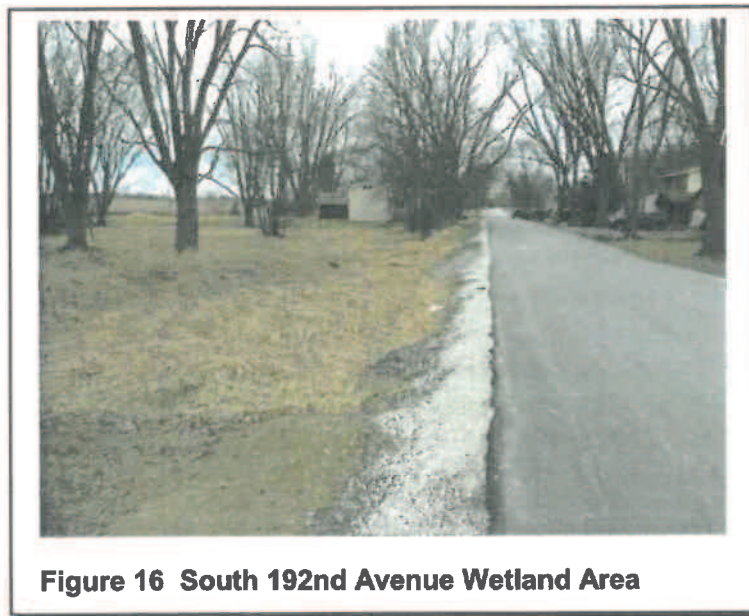
Figure 16 South 192nd Avenue Wetland Area

Low areas west of 192nd Avenue do provide some benefit for retaining flow and thereby minimizing flooding impacts to the east under certain rainfall events. Overall, stormwater throughout the neighborhood on both sides of 192nd Avenue does not have a direct way of draining out of the neighborhood since flow is restricted on the Canal. Within the local drainage area, stormwater does not have a convenient way of draining from the west side of 192nd Avenue to the east side toward Dutch Gap wetland area (refer to Figure 16). Creating a drainage path, either by installing a culvert or inlet and storm pipe, may not improve overall drainage conditions until drainage improvements are implemented on the Canal and wetland area. After the Dutch Gap improvements are implemented, an inlet could be installed near the roadway in the ditch line of the south wetland area and connect to the existing inlet in the north wetland area with a pipe running parallel to 192nd Avenue. Connecting the two wetland areas would provide a way to drain the south wetland area during large storm events as part of the larger local system. If this improvement is implemented before Dutch Gap improvements are made, this could worsen flooding in other areas of the neighborhood.

5. 192nd Avenue Storm Sewer Improvements
(Only after Dutch Gap Canal Dredging, \$50,000)
