# **George Lake Aquatic Plant Management Plan Update**

**Prepared for:  
George Lake Rehabilitation District  
Bristol, Wisconsin**

**Prepared by:  
Kathleen M. Paap  
18709 102nd Street  
Bristol, WI 53104**

**Jan. 2020**

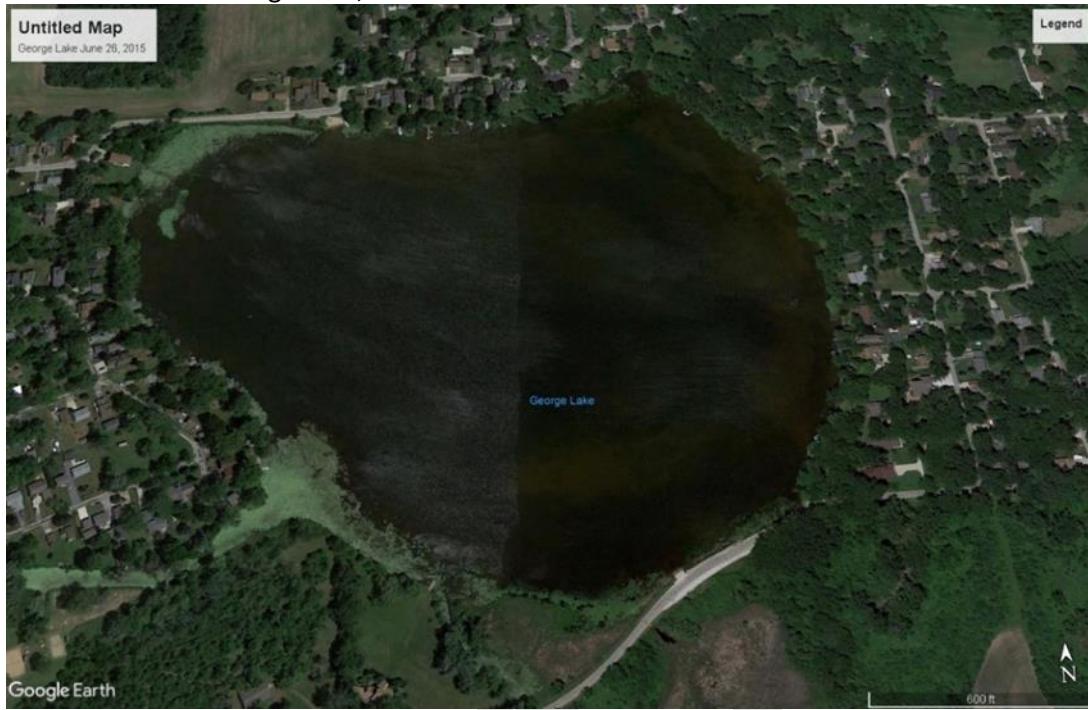
a. Aerial of George Lake, June 2015

There are cases where the abundance of white waterlily has hindered the ability of shoreline homeowners to recreate at their docks and access the lake. White waterlily does provide habitat for a variety of aquatic organisms, so it is favorable to allow this plant to thrive in certain areas of the lake; however, the GLRD is interested in exploring spot treatments of areas dominated by white waterlily where it is restricting lake access and shoreline recreation. GLRD is additionally concerned that if it does not manage the spread of white waterlily into these areas, homeowners will take it upon themselves, possibly causing injury to desirable native vegetation. Some of this activity was noted during the 2019 spring and fall aquatic plant surveys and is evident in Google Earth historical aerials: a.) June 2015 and b.) July 2018 (below).

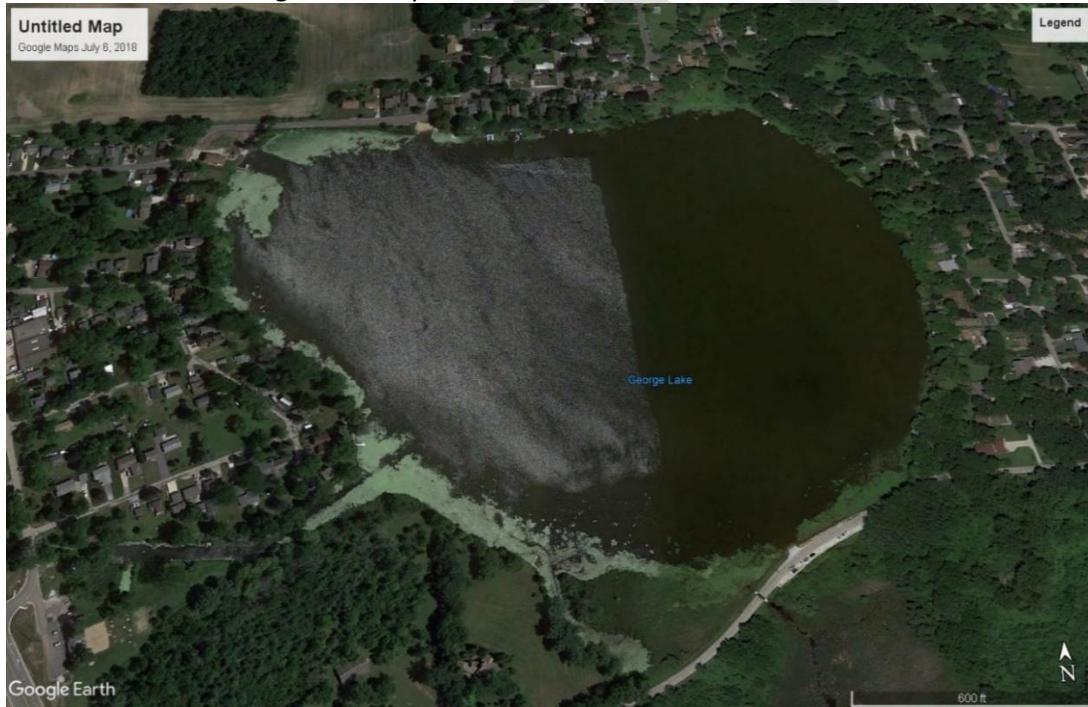
b. Aerial of George Lake, July 2018

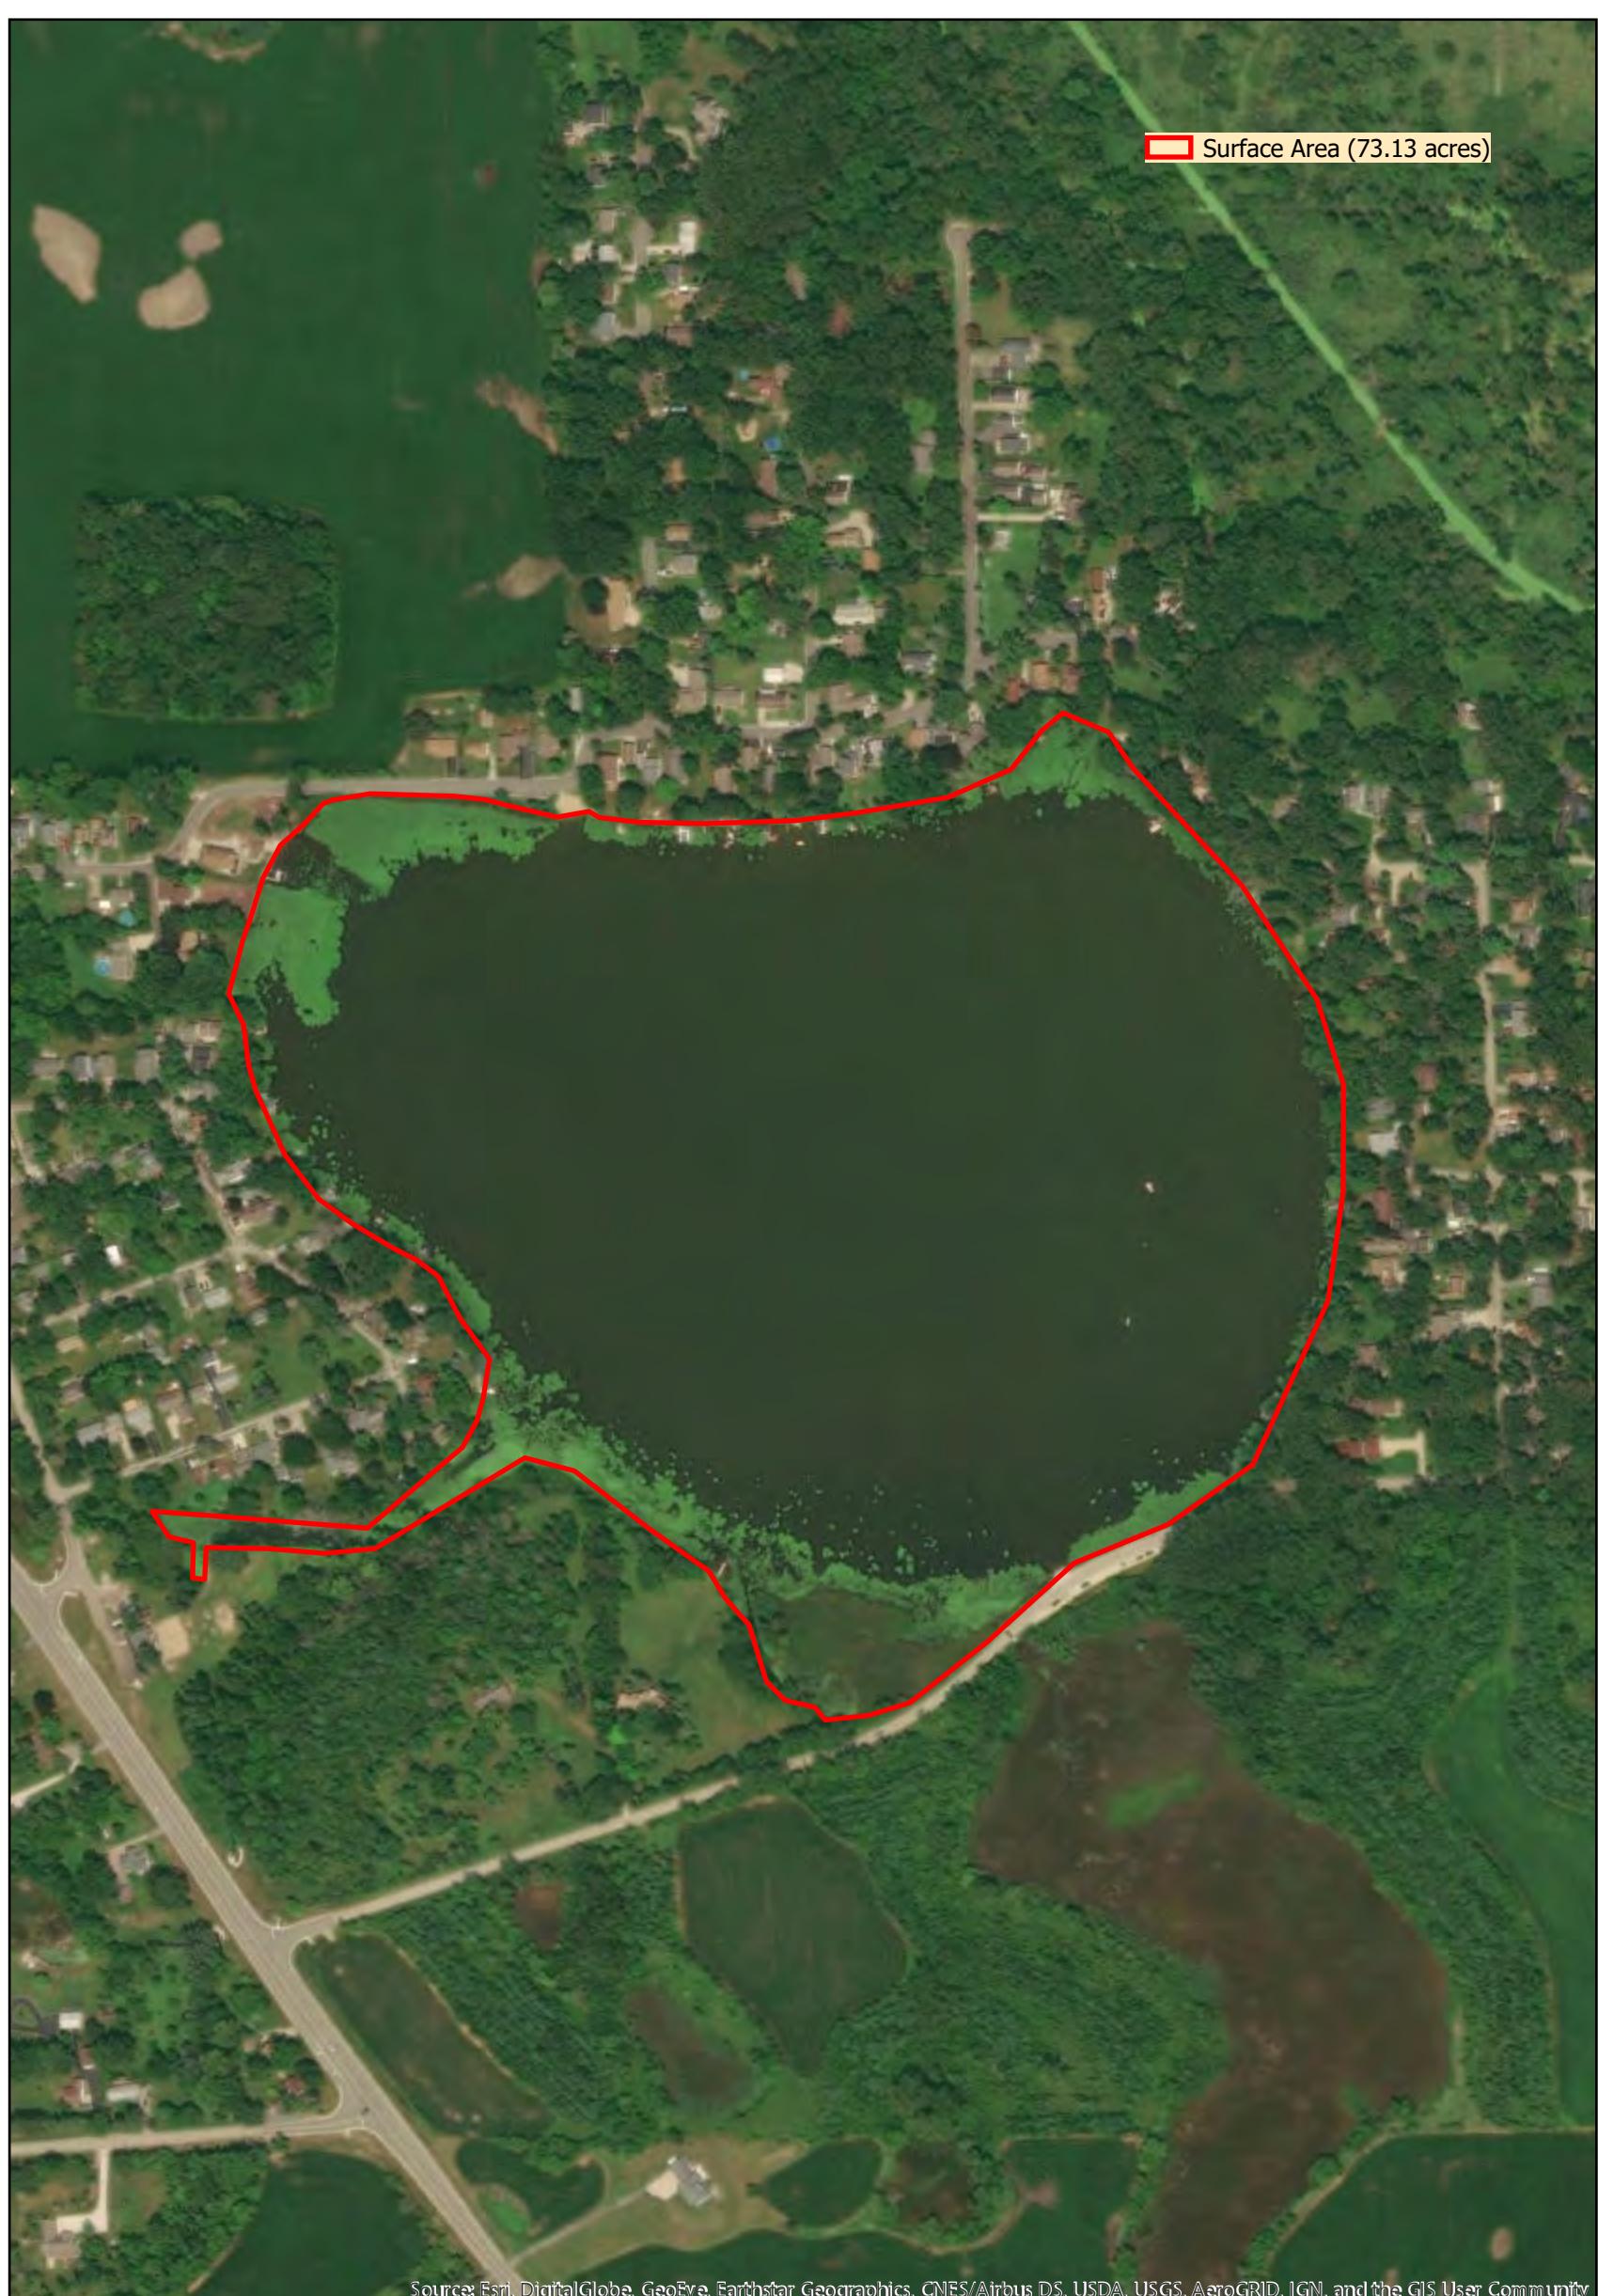
**Figure A-1. Surface area of George Lake (73.13 acres).**
